Avoidable Showstoppers During Aircraft Transitions

by Cengiz Armutlu
Industrial Engineer, ISO/IEC
17024 Certified Expert

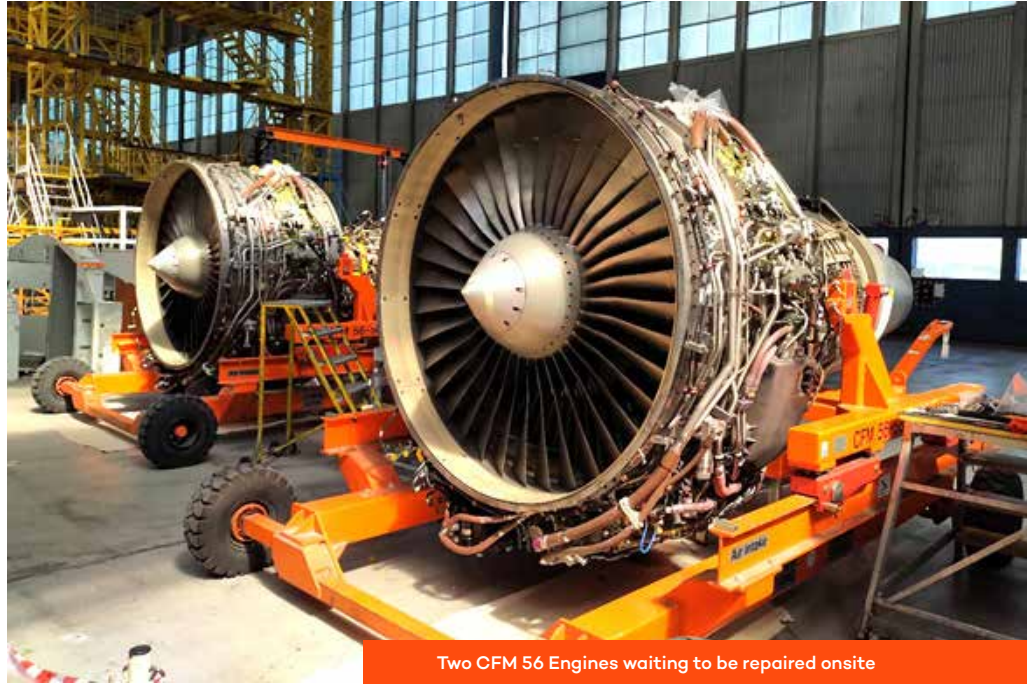
Two CFM 56 Engines waiting to be repaired onsite

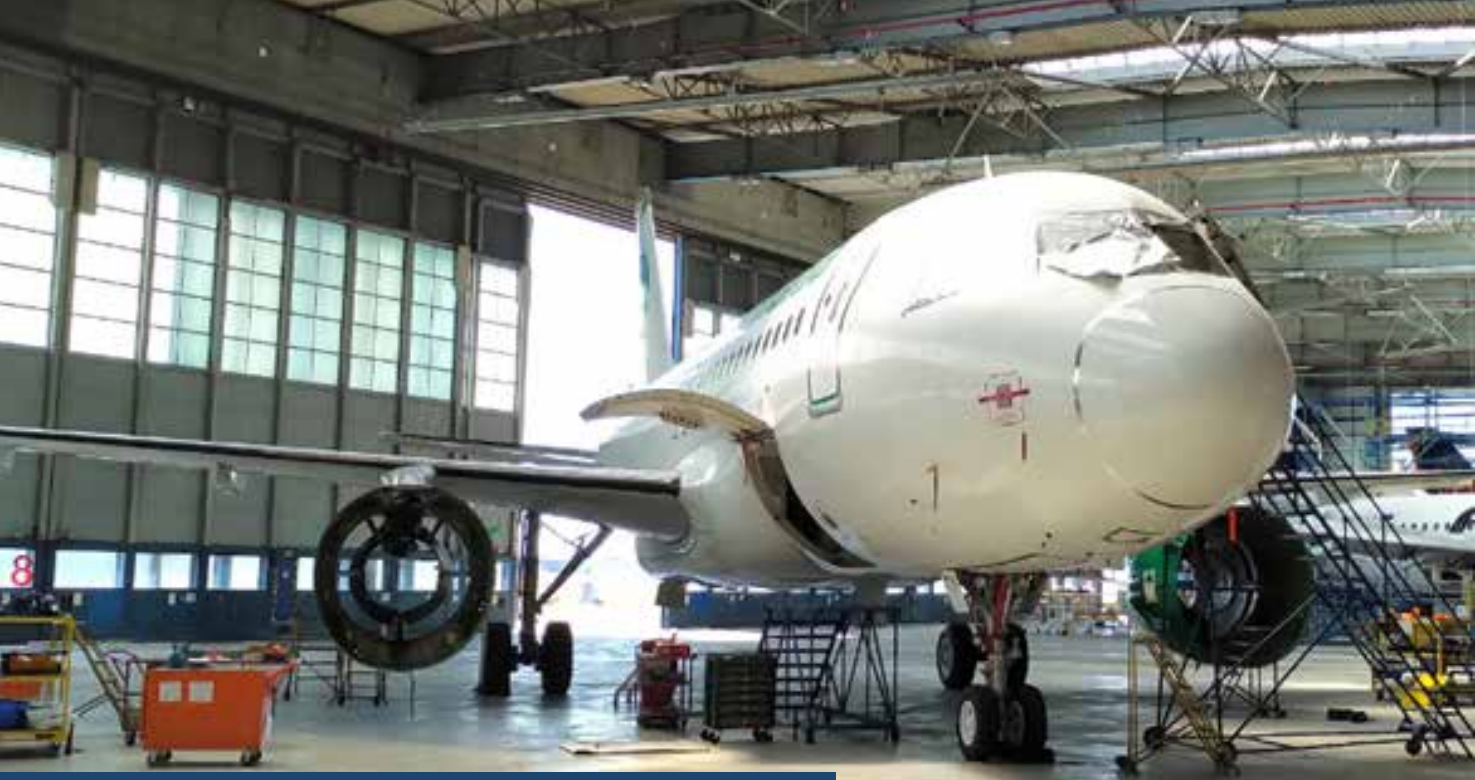
An A319 waiting for its two CFM56 Engines to be reinstalled after repair
